**VIETNAM INFRASTRUCTURE DEVELOPMENT
AND FINANCE INVESTMENT JOINT STOCK COMPANY**

**MONITORING REPORT ON
AGGRADATION OF RIVERBANK, LAND
EROSION AND FLOODING RISK**

**THE EXPRESSWAY HA NOI – HAI PHONG PROJECT
The Third monitoring of locations of packages**

Hanoi, September 2012

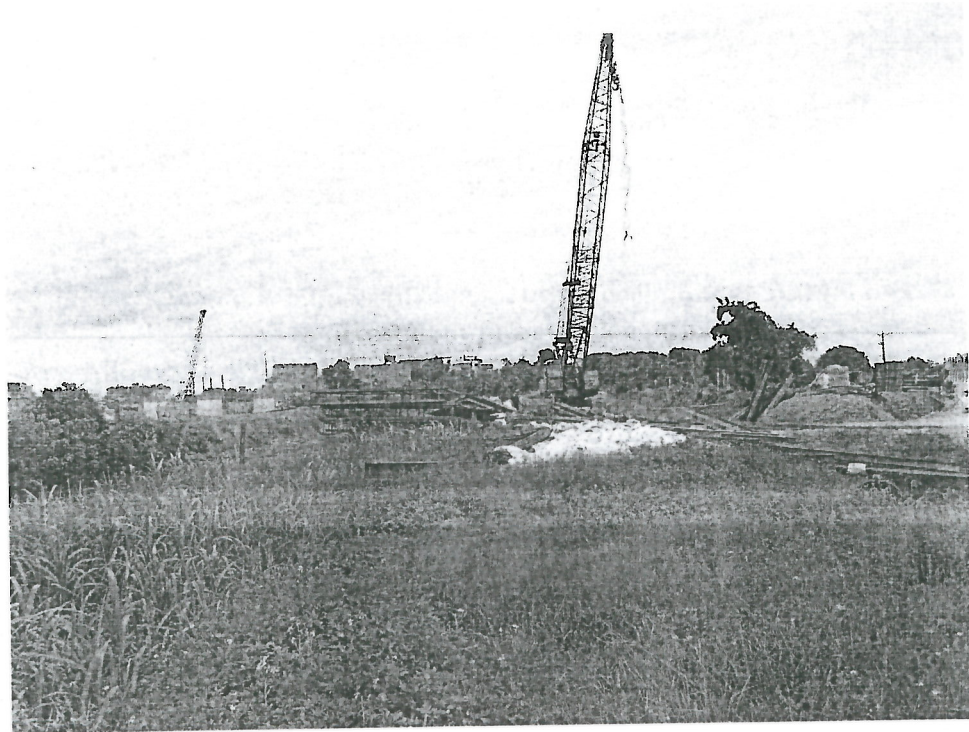
Figure 1.1. Overview of the overpass construction sites in the Cuu Cao

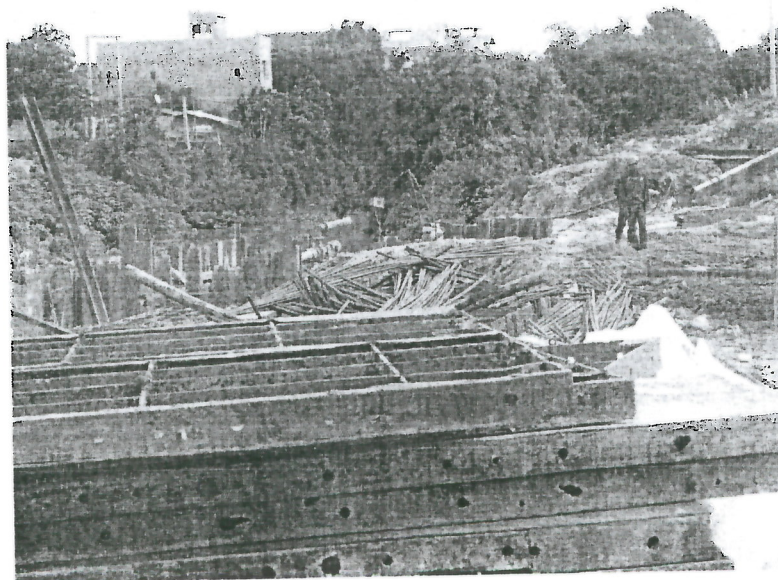
In which, the river is deformed strongly from the south of the village (Figure 1.2). Here, the obstacles is diaphragm wall with steel piles which is located in middle of the flow. Beside, construction material (gravelly soil) is run down the river (Figure 1.3, 1.4).

Figutr 1.2. River is view from the field (the South)

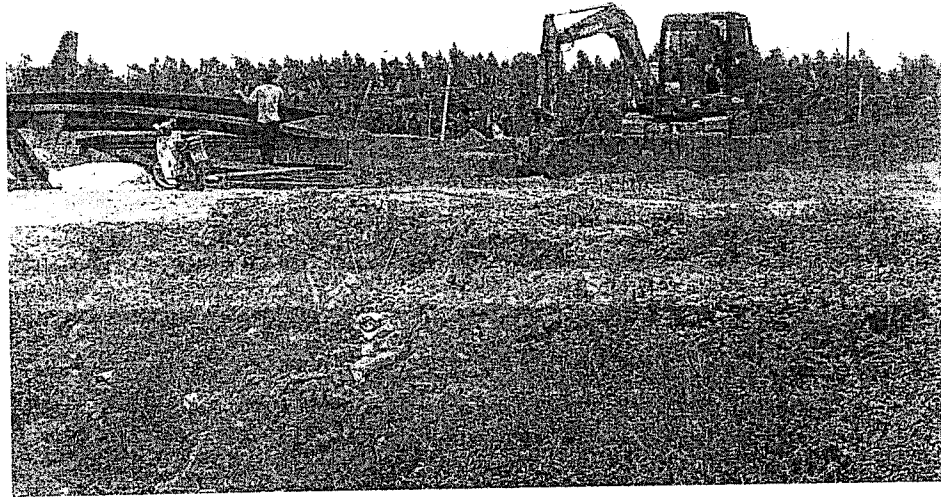
Figure 1.3. Construction material is run down the river

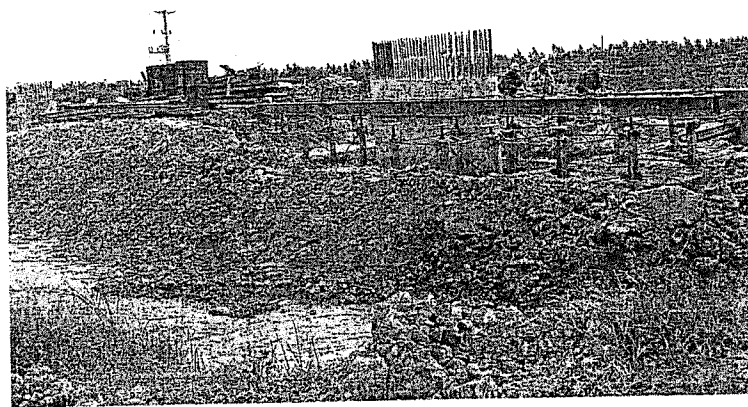
Figure 1.4. Flow of the river is narrowed by abutments and construction material

will make flow velocity greater than normal. The results of the low velocity measured in many different positions on the water show that at the narrowest cross – section by wall piles, the flow velocity is 2-3m/s, while the downstream velocity less than 0.1 m/s.

- Revetment wall which is built by steel sheet piles that still exists on the river surface. The shortest distance between the two riverside is 6m.

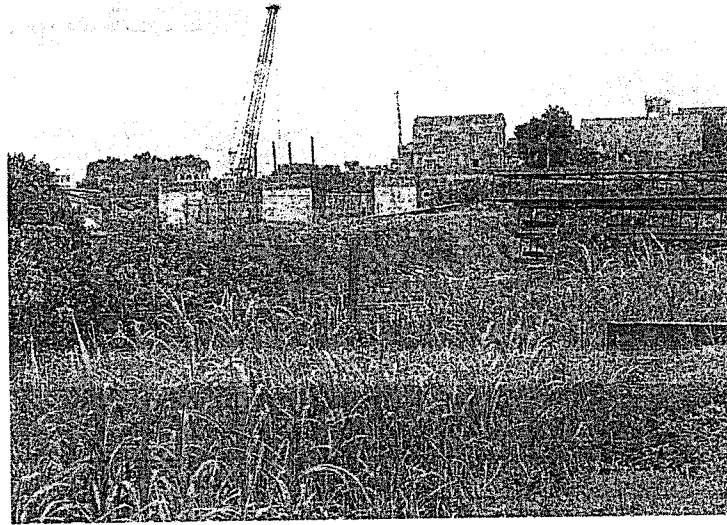
In the Northern shores of the river, piers located far from shore, the influence of the construction in this period to cross the river is negligible (Figure 1.5). Mainly the topography surface changes take place in the previous cycles.

Figure 1.5. Abutment construction in the North

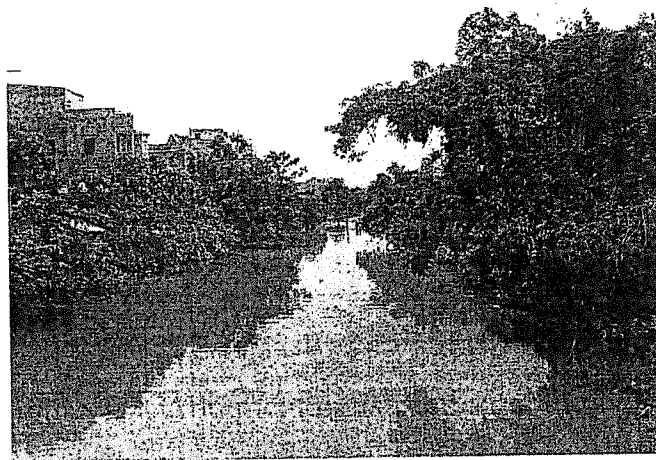
Construction processing has effected to the flow of the Bac Hung Hai river. State of the flow is changed, in which velocity of the down stream flow is very small compared to the bridge area (Figure 1.6).

Figure 1.6. Flow after the rain

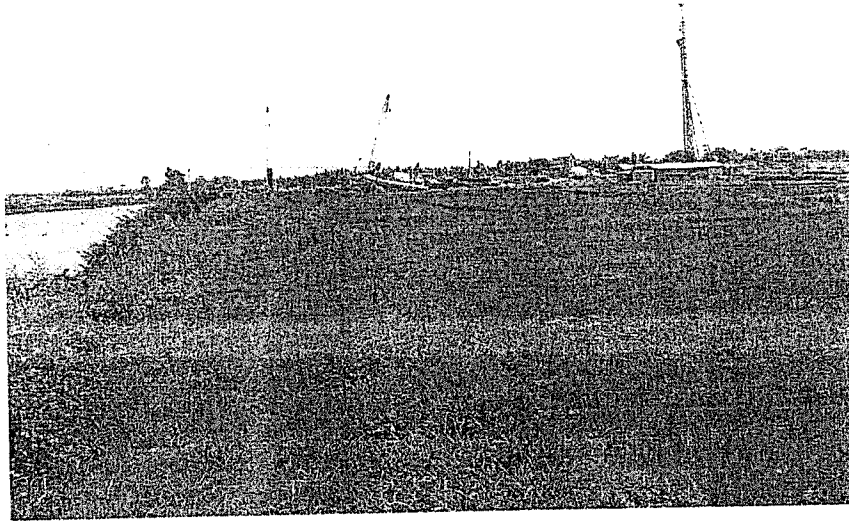
Figure 2.1. Overview on the Bo Xuyen bridge construction site

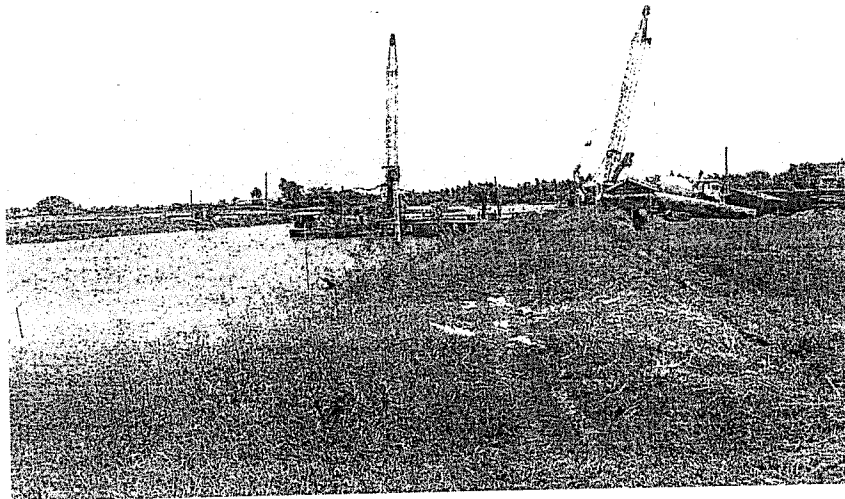
For with pile construction activities are implemented in the flow of the river on the floor and floats. So the fill line to gather material occurs in (2.2). However, in the process of drilling and pouring concrete (Figure 2.3) drilling waste material and humus partially filled flow down.

Figure 2.2. Boring bridge foundation

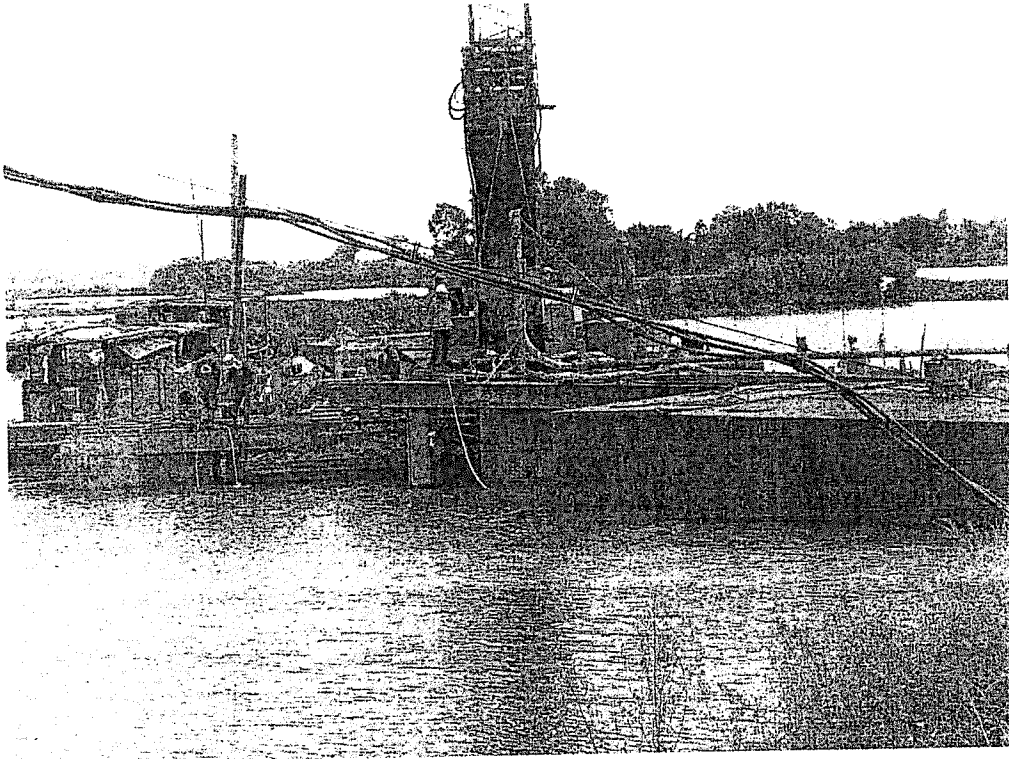
Figure 2.3. Concrete pier foundation pile

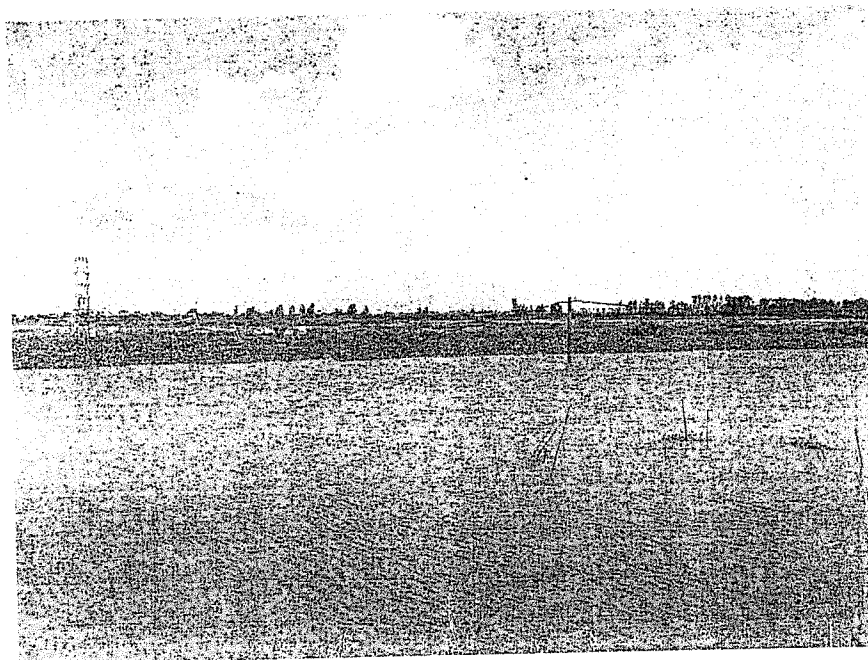
Figure 2.4. Bo Xuyen river is viewed from Binh Giang coast

built abutment piers. Therefore, terrain of coast in the northern does not change (Figure 2.4).

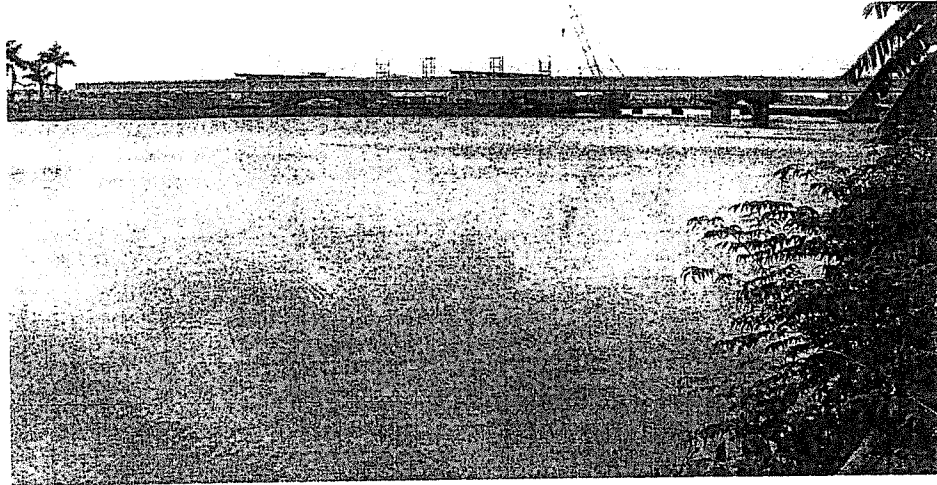
At the third monitoring time, surveying result show that the butment piers and girders were completed period from the second cycle to third cycle (Figure 3.1).

Figure 3.1. Bridge construction area

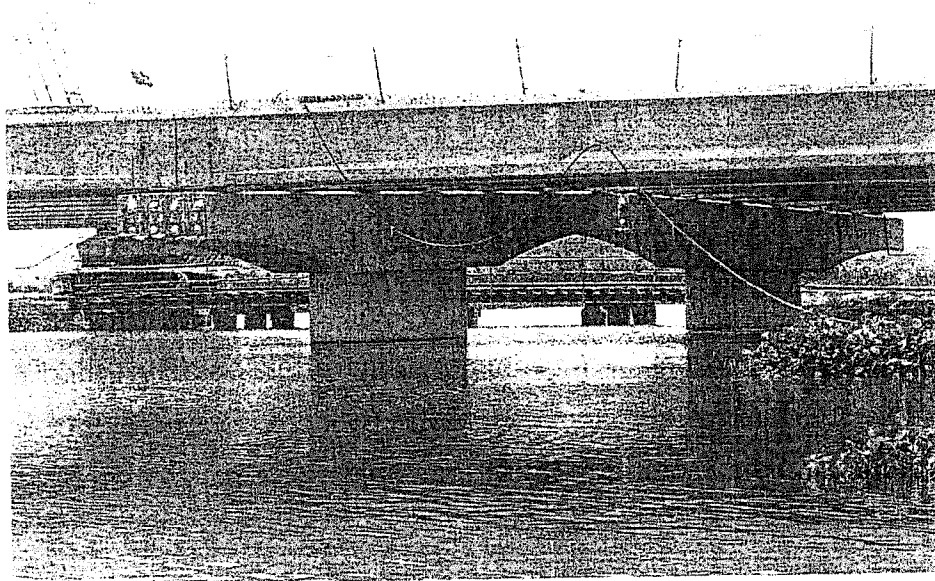
Comparing with the before cycle, at the monitoring time, landscape and terrain on both riverside significantly changes. Especially, bridge and temporary road construction have not been lifted by construction activities of abutment piers. These changes can see when comparing to photo which is taken in 2 cycle.

Figure 3.2. Bridges, temporary road

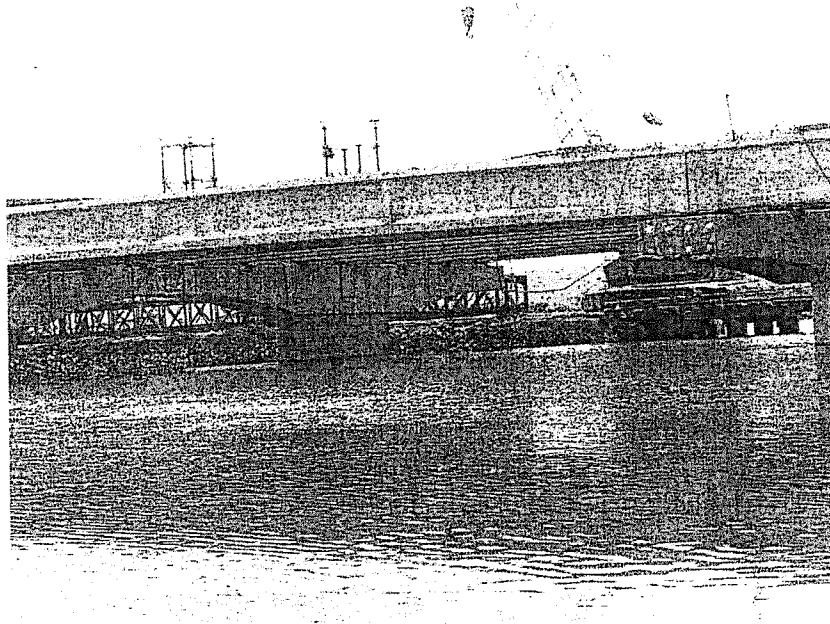
Figure 3.3. Downstream coast of the Tan Vien was completed the bridge span

In the Tan Vien shore, the land fill in the construction process, although not very high above the water level but appeared landslides phenomena for land falling into the flow and make the cliff (Figure 3.3).

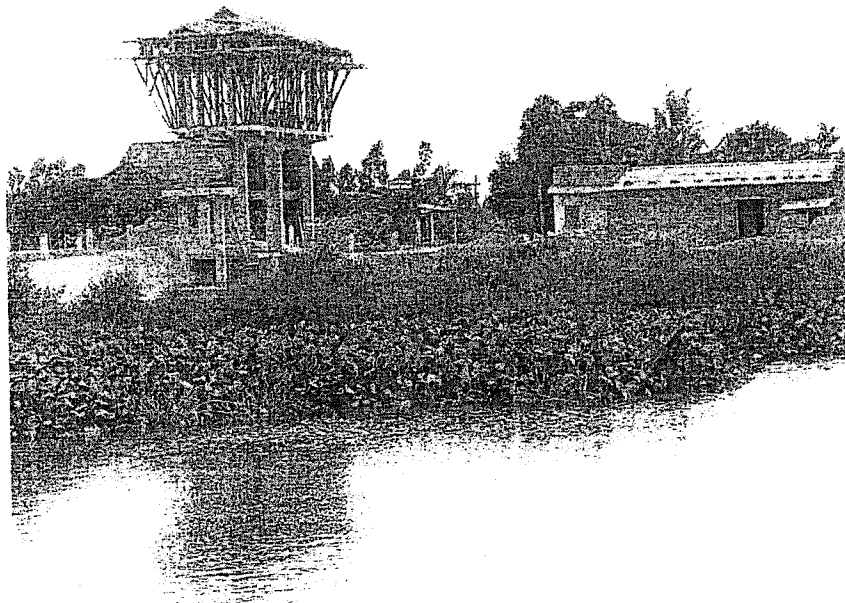
Figure 3.4. Drain construction

At the upstream area flow is far from bridge approximately 200m, at the time of monitoring, an irrigation drain has been completed, but not yet use.

Drainage adit which across the drain that still filled.

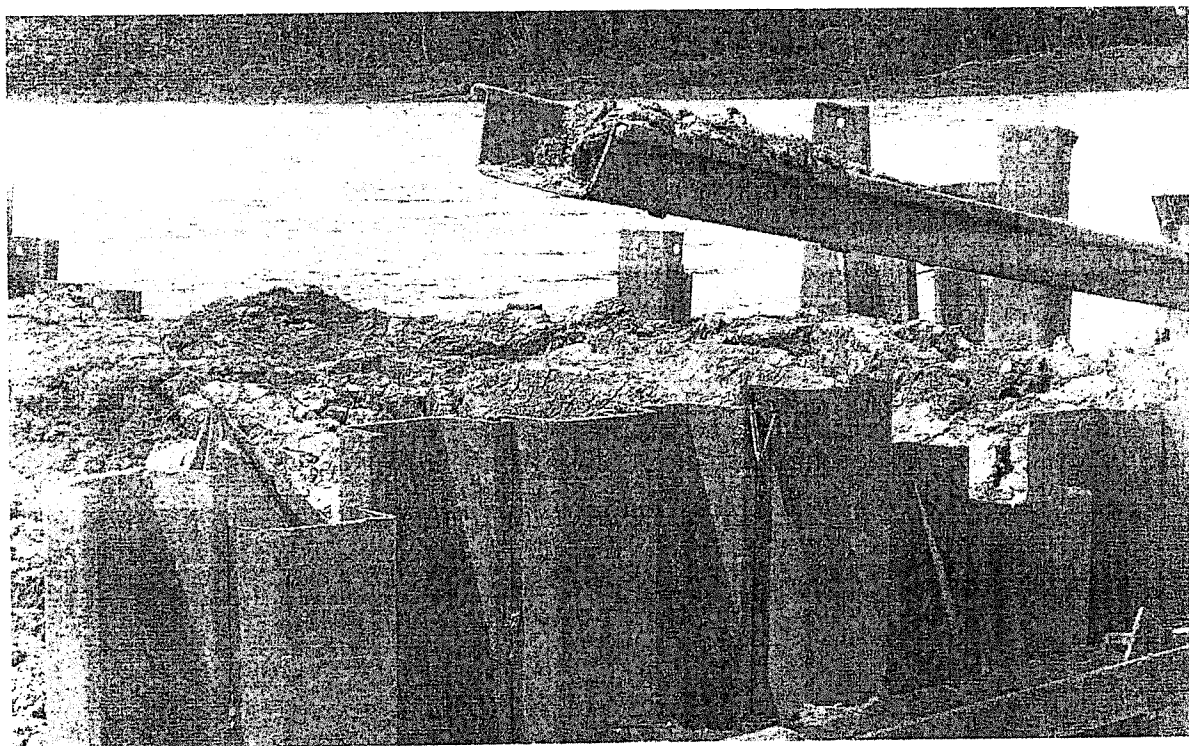
Figure 4.1. Status of riverside in the west Kien Thuy

The coast of the Kien Thuy is carrying out bustling construction activities, the abutment piers are in the final phase with the beginning phase of the construction process the mast body (Figure 4.1 and 4.2).

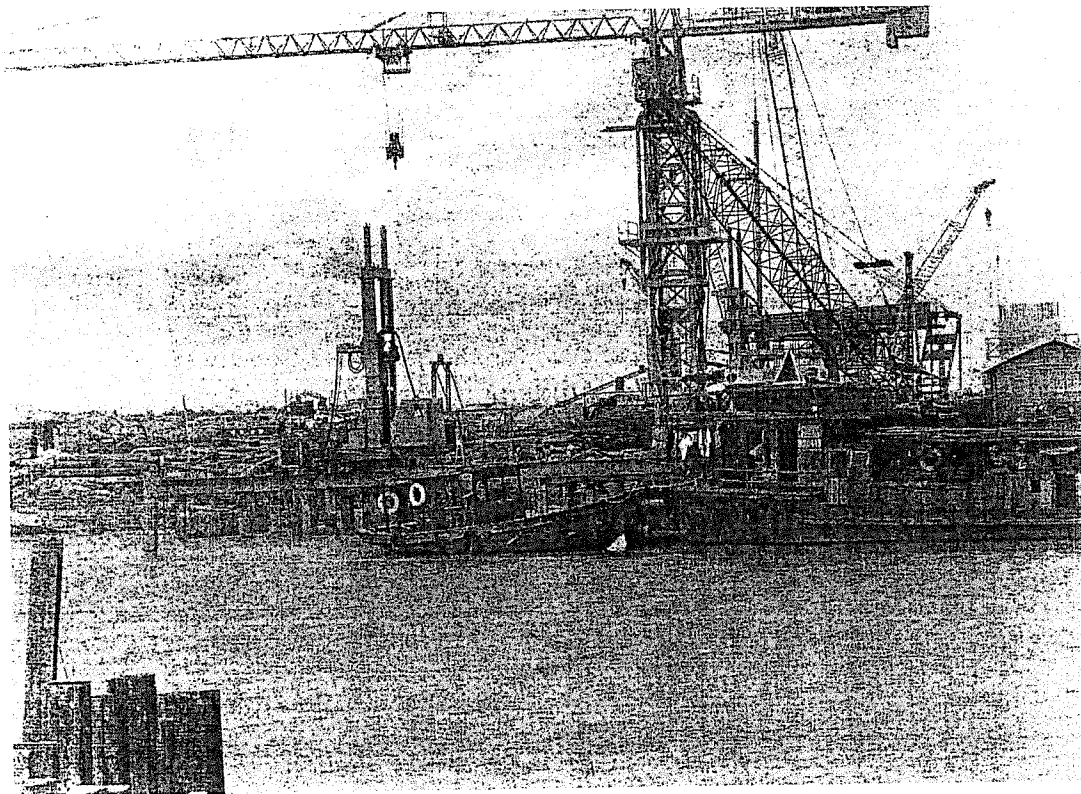
Figure 4.3. Construction sites on the east of the Dinh Vu
In general, the river bed has been a change and is narrowed by by the

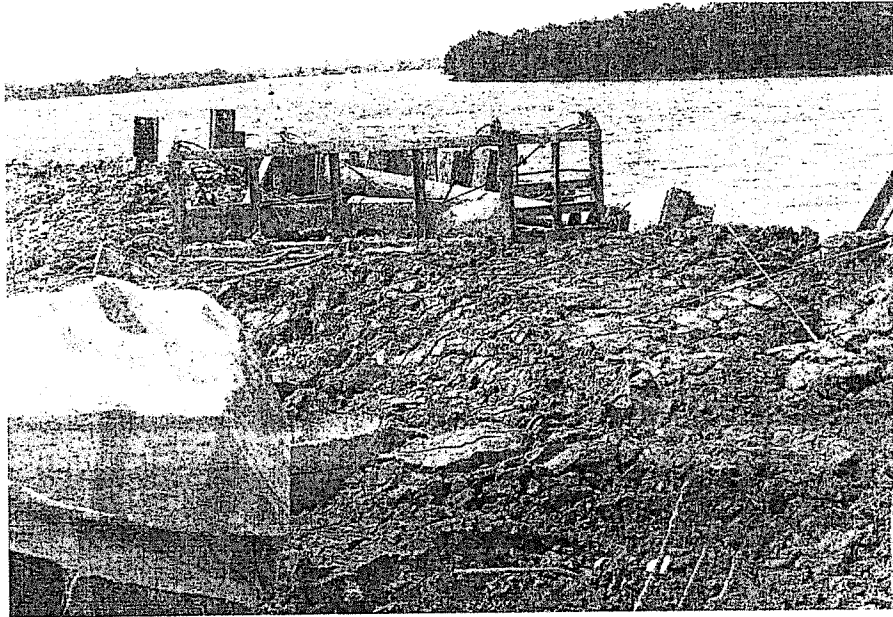
waste material in the shore of the Kien Thuy (Figure 4.4) and crowd flow as well as construction equipment in the shore abutmentline of the Dinh Vu.

Figure 4.4. Status of spoil area in the Kien Thuy shore

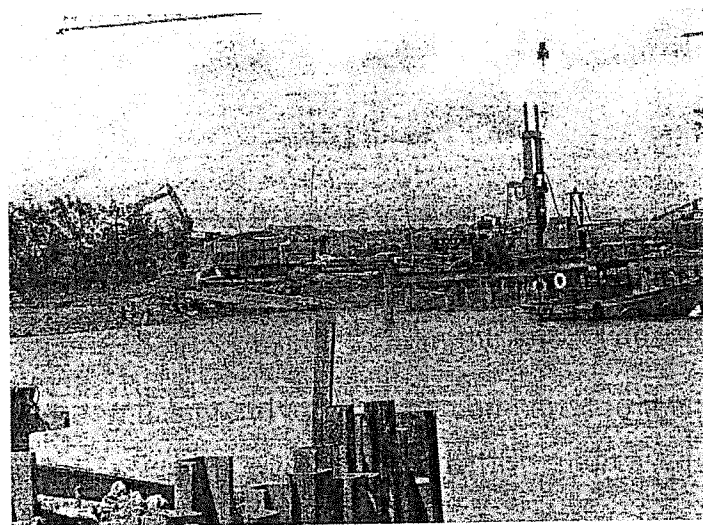
Closure condition has greatly increased compared to the previous cycle, at the time of observation, length was filled with flow increased by more than 10 meters.

Figure 4.5. Overview on closing of dam in two riverside
