6.0 GEOLOGY, SOILS AND CONTAMINATED LAND

6.1 Scope

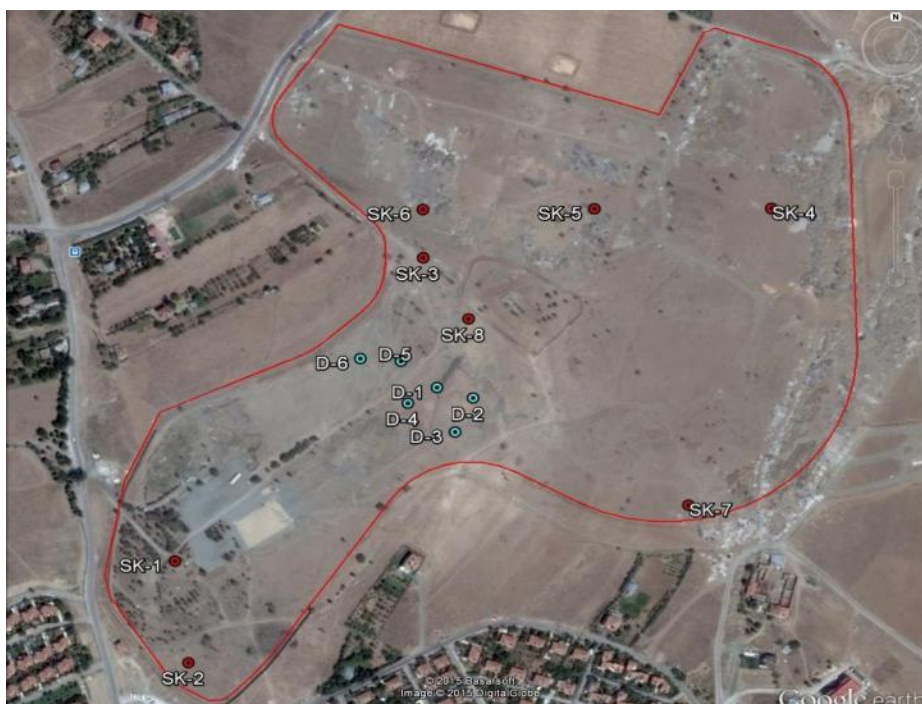
Figure 6-9: Borehole locations for soil quality assessment

The scope of the study involved borehole advancement, soil sampling and analysis at the locations given in Figure 6-9:

- Soil sample analysis: soil samples were screened during drilling for presence of organic and volatile contamination through the use of a portable photo-ionization detector (PID). Based on the PID screenings and visual observations, a total of twenty two soil samples from fourteen drilling locations were selected and sent for laboratory analysis. Samples were shipped to Agrolab in Germany (accredited laboratory) to be analyzed for Total Organic Halogens (TOX), Total Petroleum Hydrocarbons (TPH), Volatile Organic Compounds (VOCs) including Benzene, Toluene, Ethyl benzene and Xylenes (BTEX), Polycyclic Aromatic Hydrocarbons (PAH) and Metals (As, Ba, Cd, Co, Cr, Cu, Hg, Mo, Ni, Pb, Sb, Se, Sn, V, Zn); these parameters were selected which in accordance with the RSPC conditions.
